Locomotive Aftertreatment - Project Updates

Steven G. Fritz, P.E.

Department of Engine and Emissions Research
Southwest Research Institute®

June 10, 2009

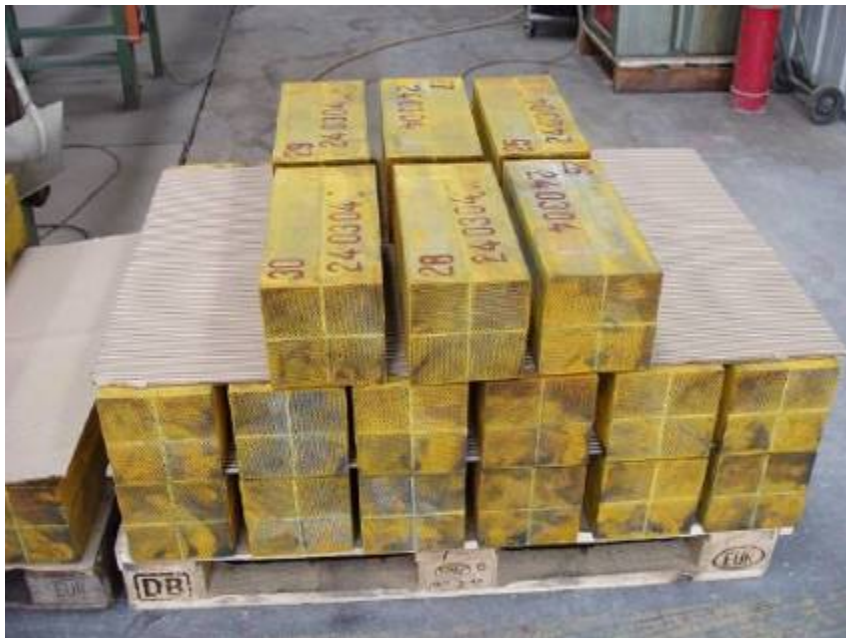
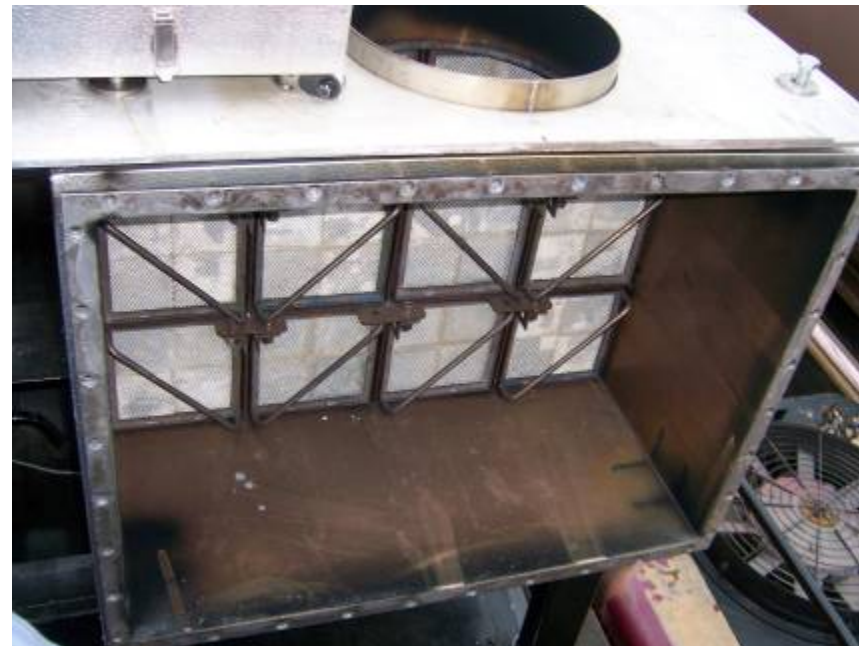
DPF Selected for Demonstration

- * MobiClean™ DPF has diesel burner
 - » Needed to provide adequate temperature for regeneration of DPF

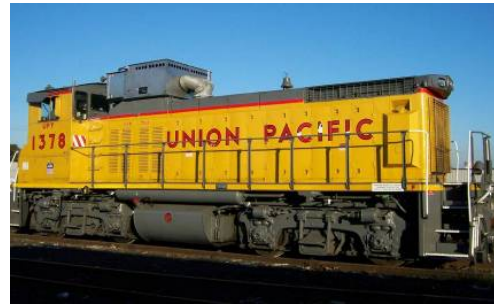
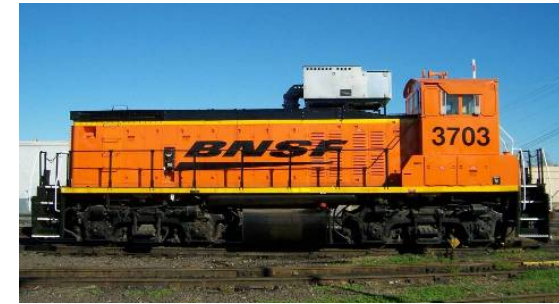
DPF Demonstration Locomotives

Locomotive	UPY1378	BNSF3703
Date into Service with DPF	Oct. 2006	April 2008
Months in Revenue Service with DPF	32	11
DPF Running Hours	5,766 (as of May 27, 2009)	3,219 1,624 Total In Calif. 4/08 – 3/09

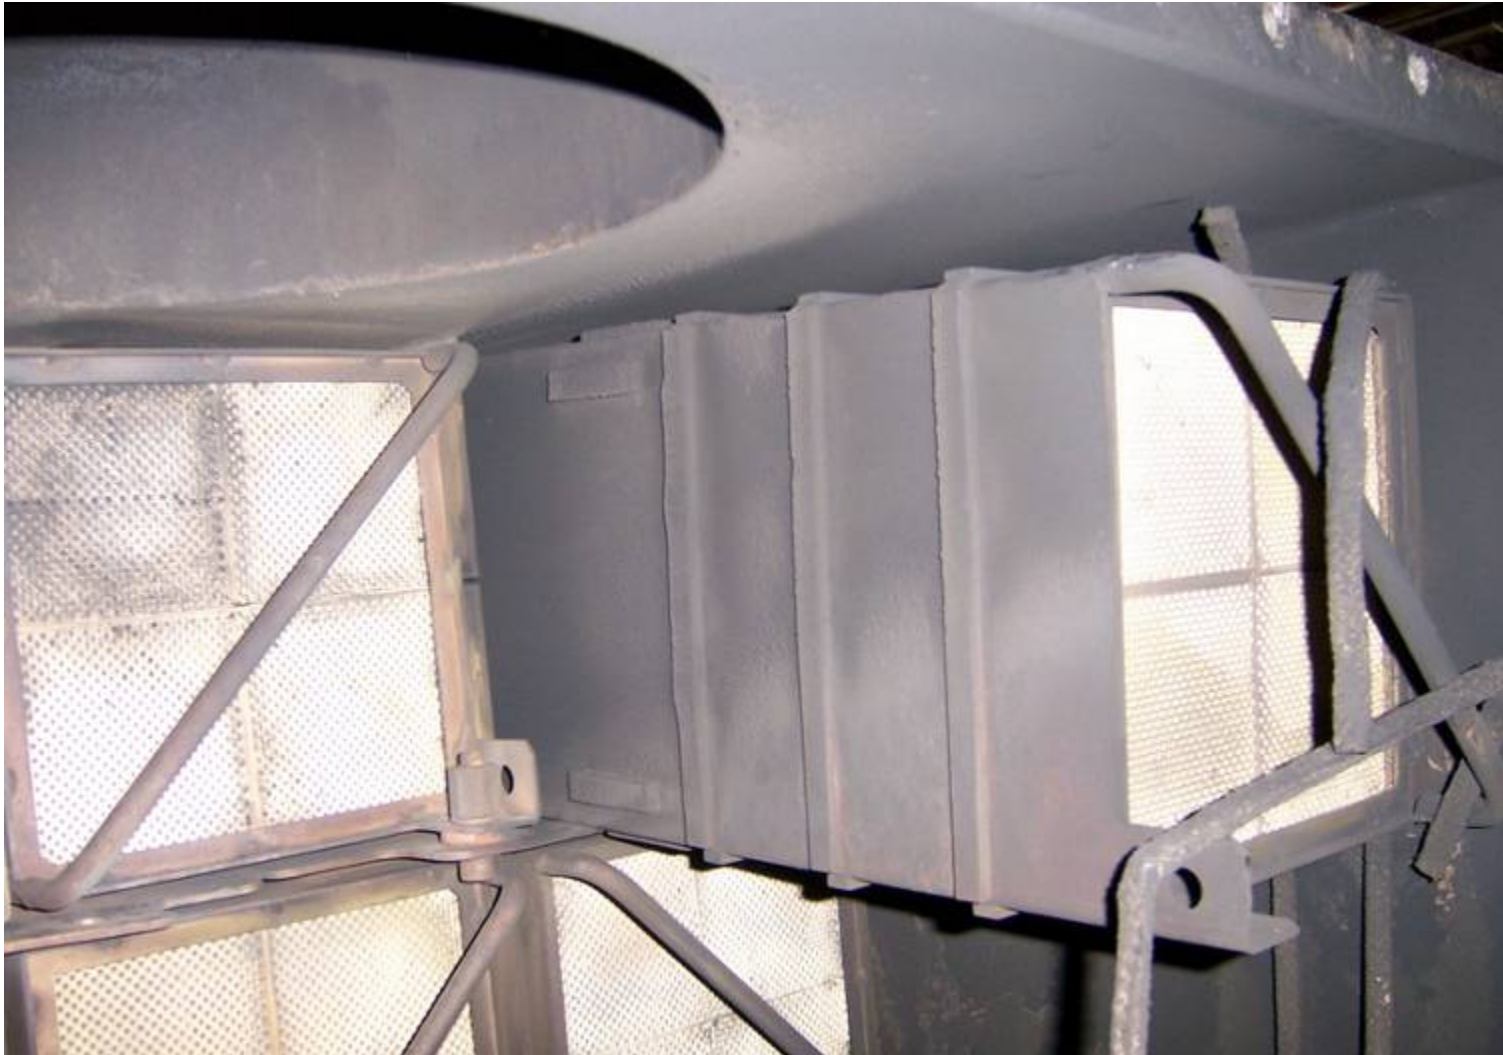
BNSF 3703 Right DPF

- * Visual inspection by SwRI in March, 2009 at BNSF Hobart Yard in Commerce, CA
 - » Noted DPF element dislodged in Right DPF
- * BNSF dragged BNSF3703 from Commerce to San Antonio
 - » Detailed inspection performed by SwRI & Miratech
 - » Miratech declared both DPF units to be unrepairable

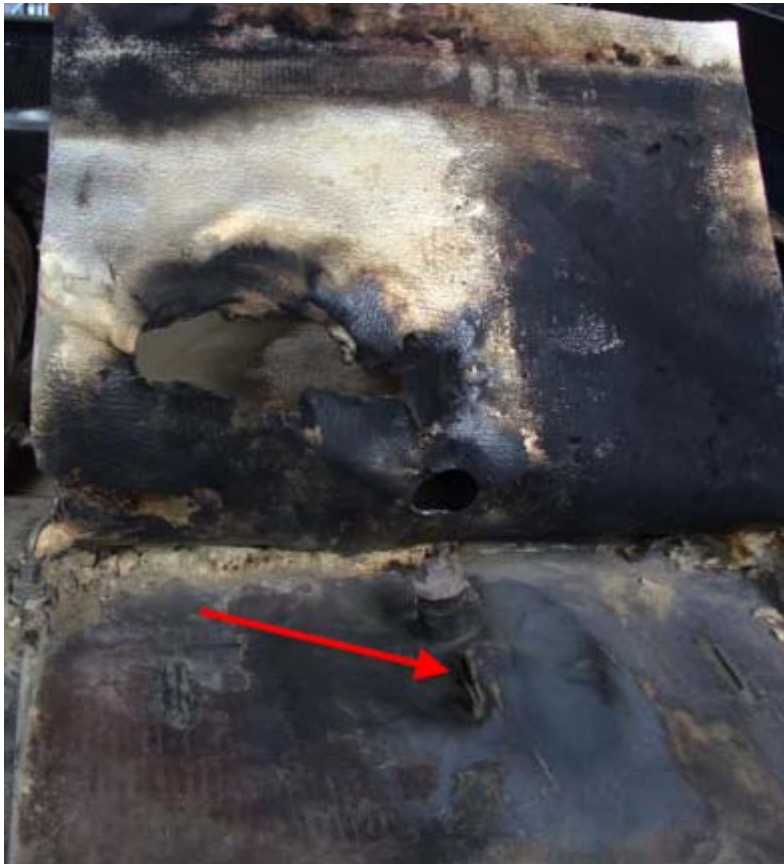
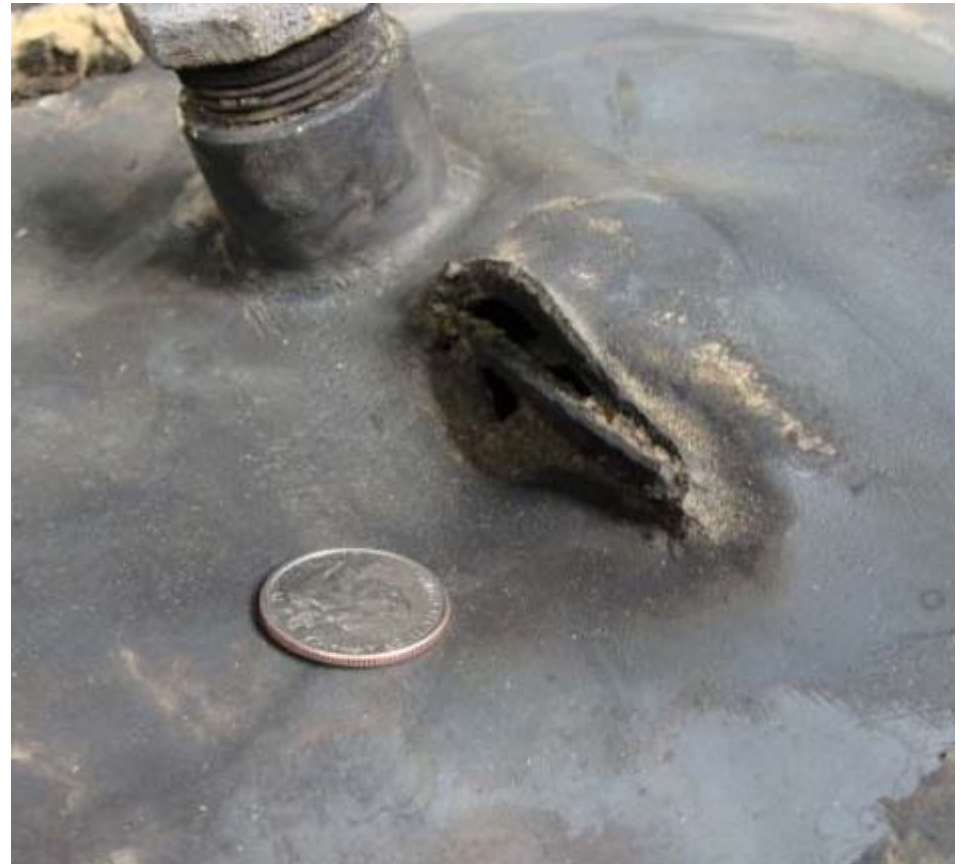
BNSF3703 – Exhaust Leak Through DPF Housing – Right DPF
